# River Don Scoping Study

Draft Report

Ardhuncart Estate

cbec eco-engineering UK Ltd

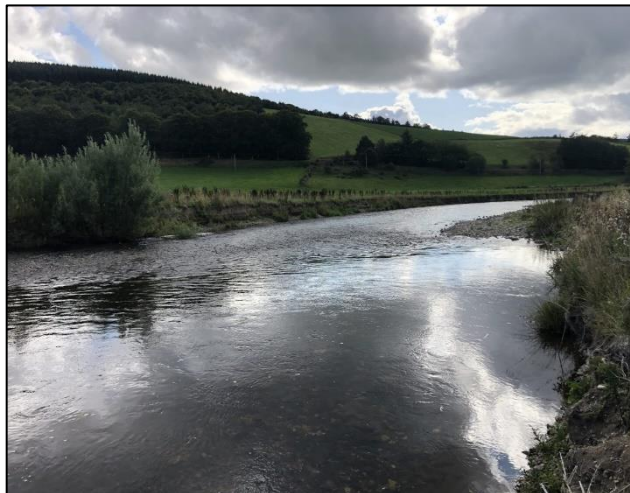
**Figure 3.1.** On approach to Cleek-Him-In-Pot pool, showing alluvial bar form on the river right bank and bank erosion on the river left.

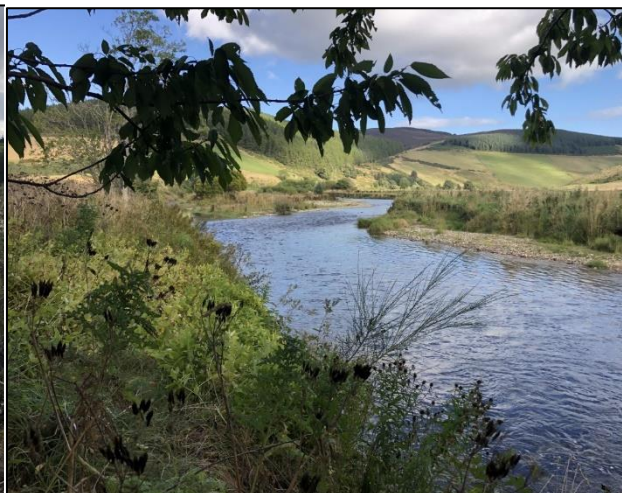
**Figure 3.2** Looking upstream to the upstream extent of the River Don within Ardhuncart Estate, showing the meandering planform with alluvial bar form. Bar forms are generally poorly developed throughout the remainder of the site.

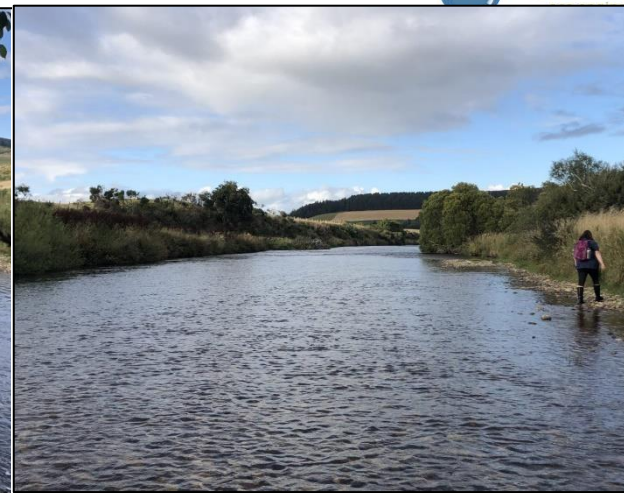
**Figure 3.3.** Proto-bar form present on the river right bank, between Cleek-Him-In-Pot and Jock Reid pools. This feature could be enhanced by installing a LWS to promote in-channel morphological and habitat diversity.

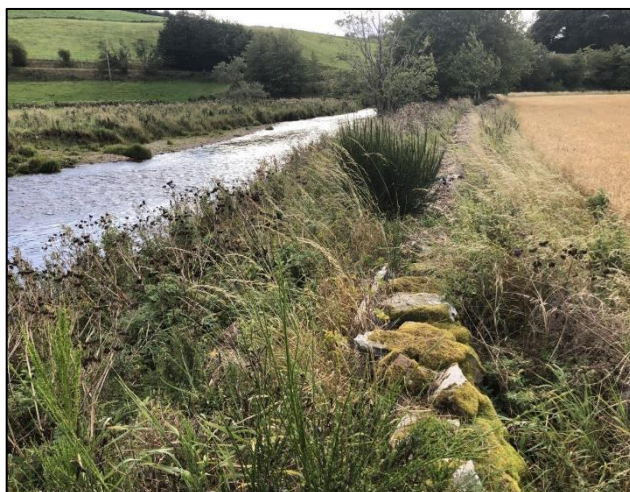
**Figure 3.4.** Example of the stone wall along the top of the River Don right bank, limiting channel floodplain connectivity.

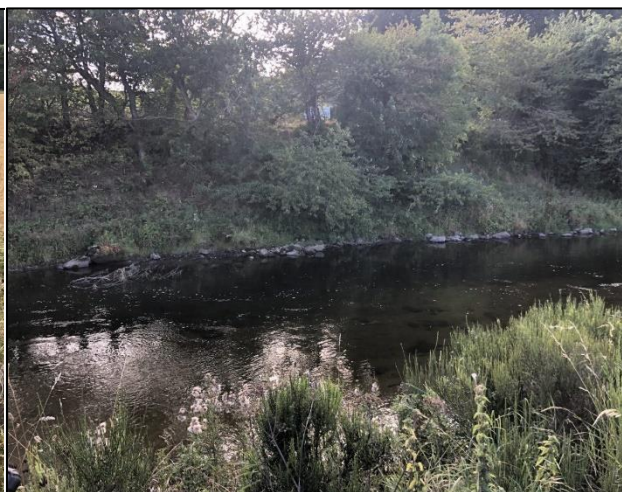
**Figure 3.5.** Stone toe protection present intermittently throughout. Photo shows a section of river left bank protection downstream of Cleek-Him-In-Pot pool.

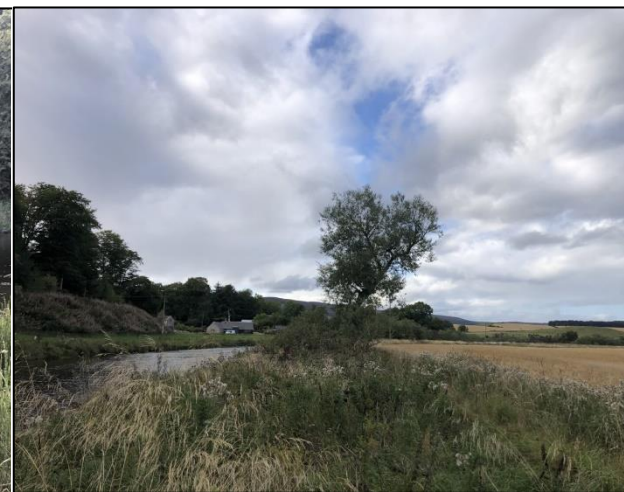
**Figure 3.6.** limited riparian corridor on river left and right banks between Cleek-Him-In-Pot and Jock Reid pool. Overhead cables on the river left may be a constraint to riparian planting.

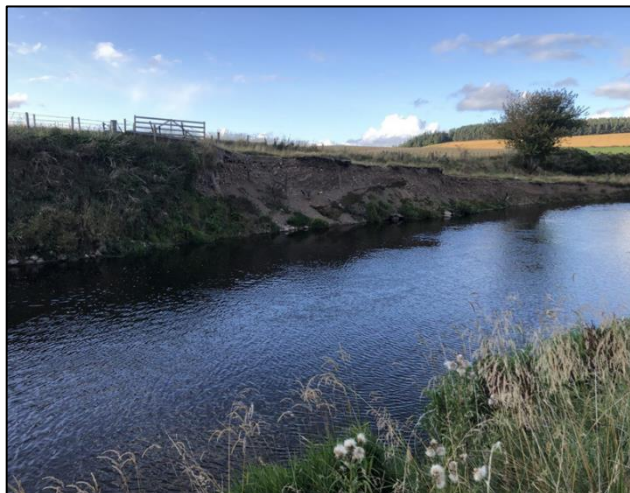
**Figure 3.7.** Bank erosion on the river left bank at Jock Reid pool, just upstream of the embankment breach area.

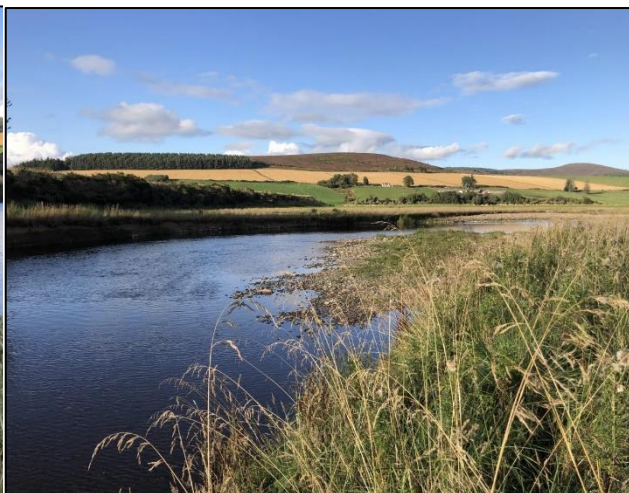
**Figure 3.8** Looking across the channel to the embankment breach area on the river left bank.

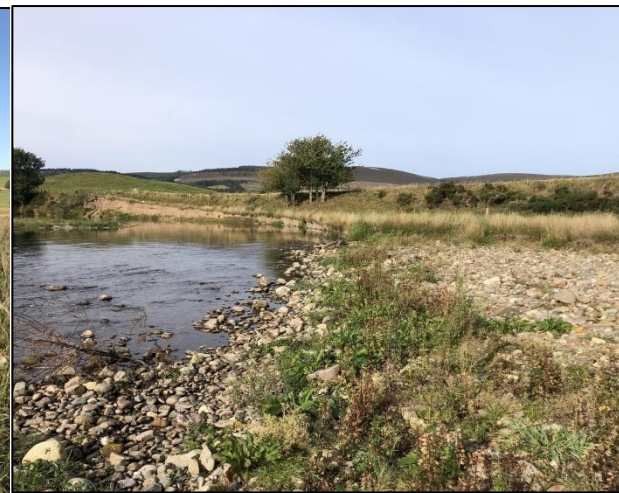
**Figure 3.9.** Looking upstream at the bank erosion, showing the low section of channel bank (~1 m high) at the embankment breach area.

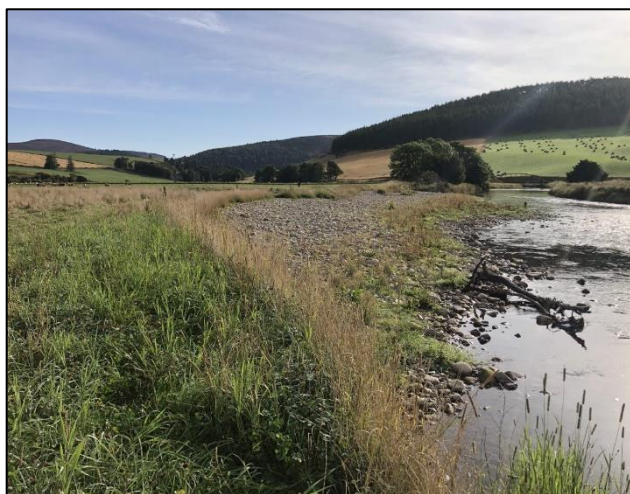
**Figure 3.10.** Looking downstream along the embankment breached bank, showing the cobble/gravel bar form that has developed along this side of the channel.

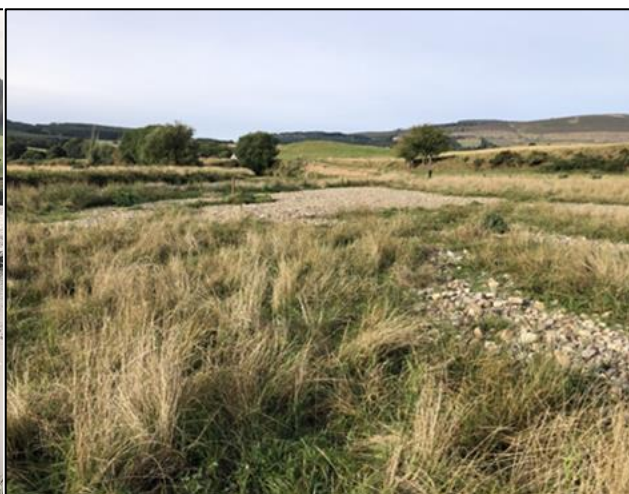
**Figure 3.11.** Cobble, gravel and fine sediment deposited on the floodplain within the embankment breach area.

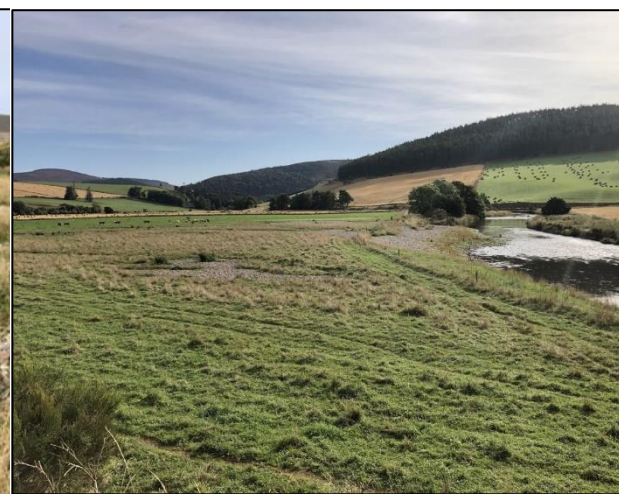
**Figure 3.12.** Embankment breach area. Continuous tree line on the top left of this photo shows the position of the Auld Water.

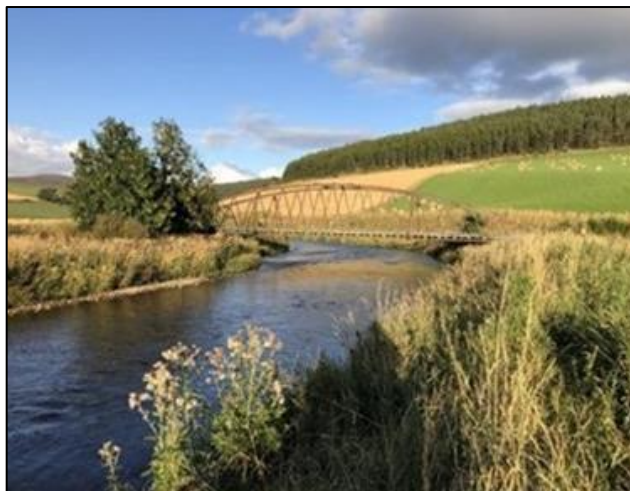
**Figure 3.13. Westside bridge, which was historically positioned further downstream (Section 2.4).**

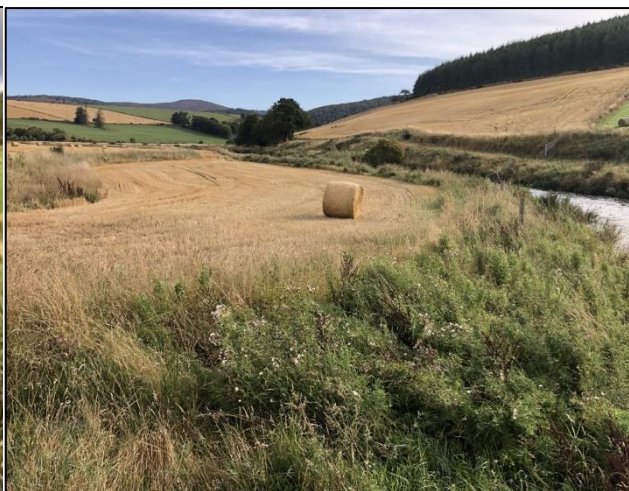
**Figure 3.14 Section of lower lying floodplain, on the river left bank downstream of the Westside bridge, used for arable farming.**

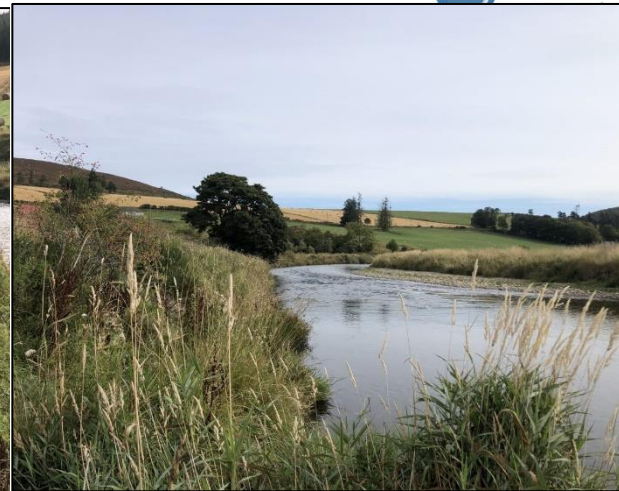
**Figure 3.15. Looking downstream towards the Auld Water confluence, entering the channel from the river left bank.**

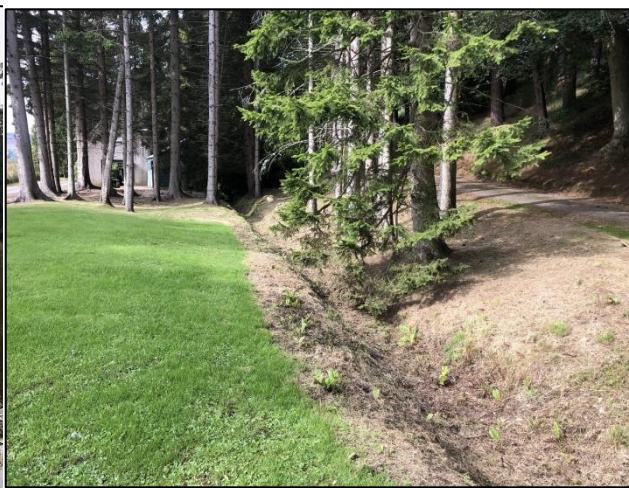
**Figure 3.17. Drainage ditch between the road to Ardhuncart Lodge and the Gardener's Cottage garage.**

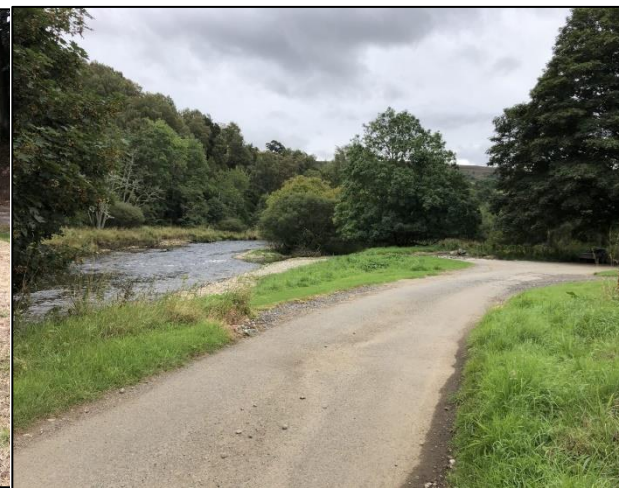
**Figure 3.18. Anecdotal evidence identified that flood water returns to the channel at this point on the river left bank, outside of the Gardener's Cottage.**

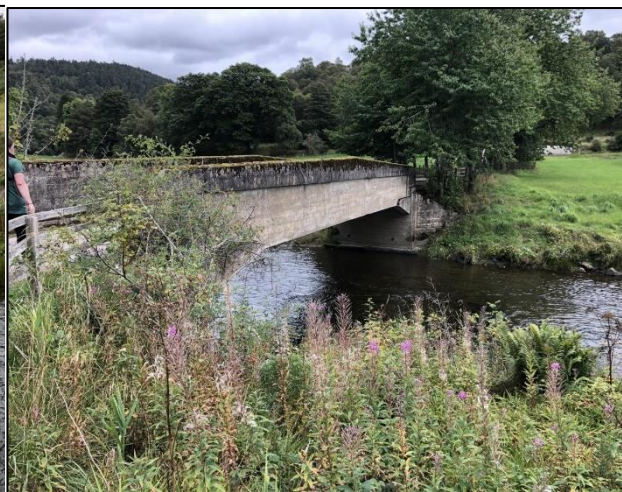
**Figure 3.20 Bridge between Delphorrie and Macharshaugh.**

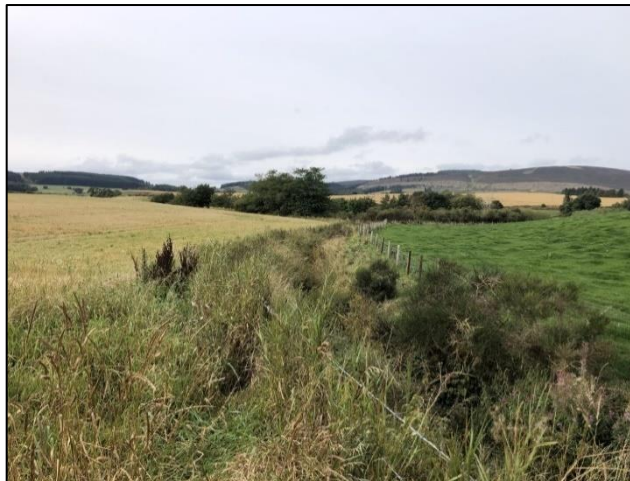
**Figure 3.22.** Looking upstream towards Templeton Bog. The channel becomes more incised upstream of this point, compared to the section downstream that runs through the River Don floodplain.

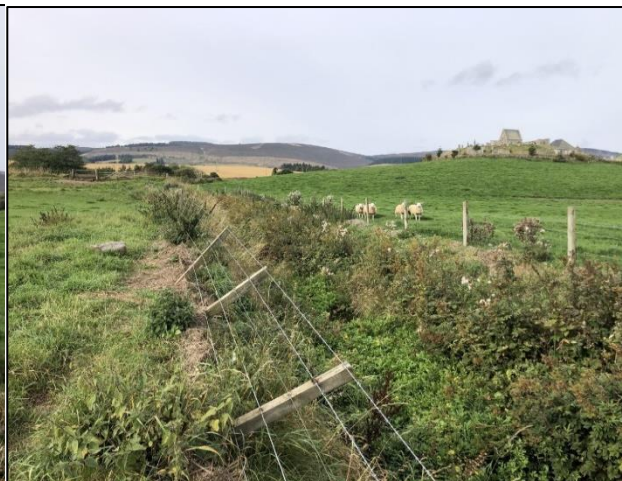
**Figure 3.23** Collapsing fence line on the river right bank, indicating bank instability. It is recommended that this fence line is set back, the bank reprofiled and riparian zone planted.

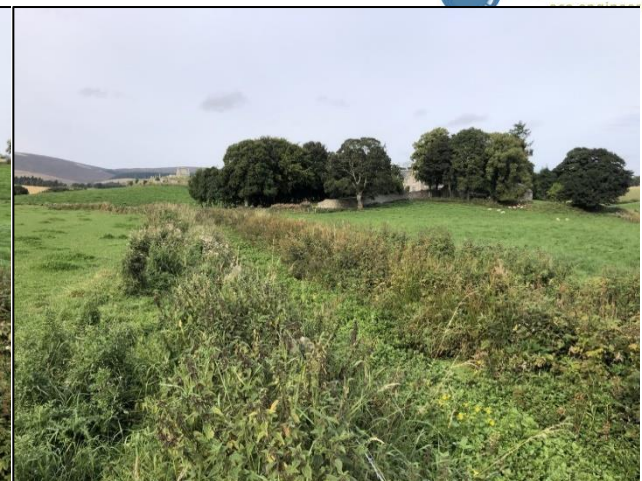
**Figure 3.24.** Auld Water, looking upstream towards St. Bride's Chapel. Channel overgrown with macrophytes, indicating high nutrient and fine sediment input.

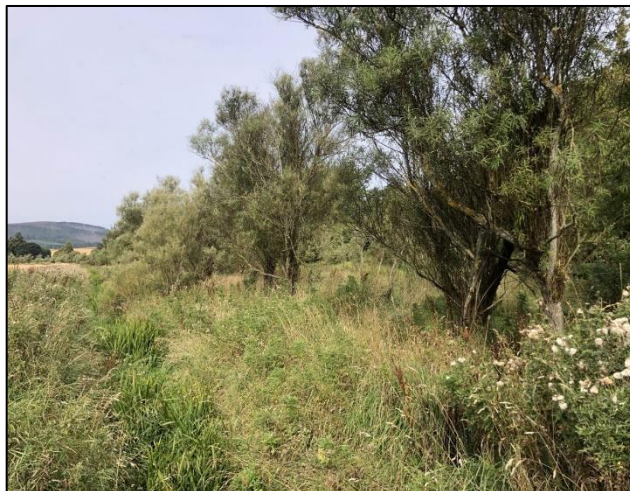
**Figure 3.25.** Looking upstream from the track, along the Auld Water. Broadleaf woodland and scrub vegetation are present on the river left floodplain, which presents potential for wet woodland habitat.

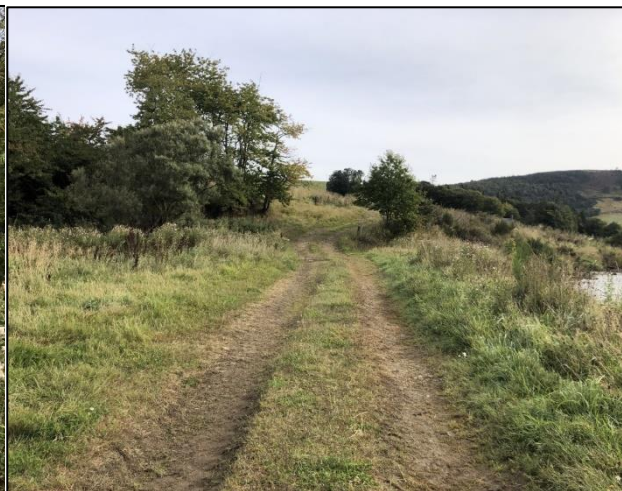
**Figure 3.26.** Track over the Auld Water, ~10 m upstream from the Don confluence. The channel passes through a culvert at this point.

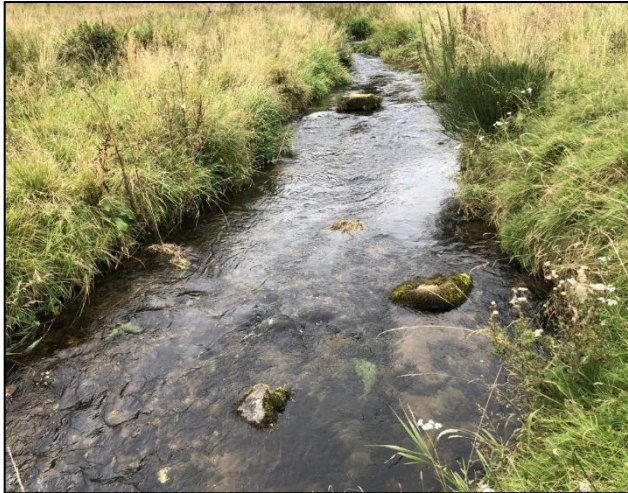
**Figure 3.28.** Cobble/gravel bed substrate is dominant throughout the lower Mossat, with few bar forms.

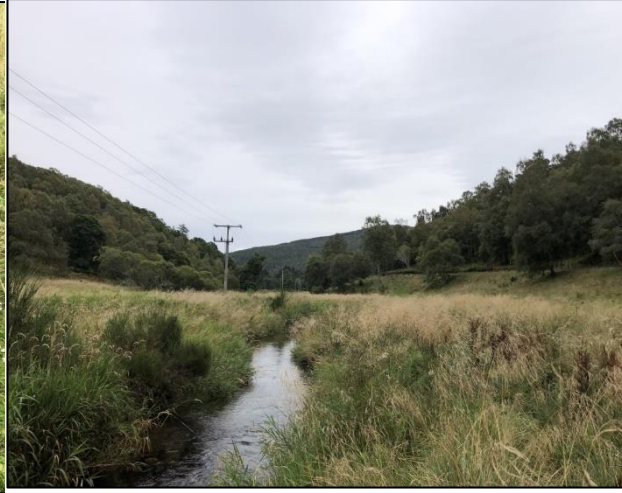
**Figure 3.29** The Mossat burn is typically 1.5 m wide and 1 m deep. This photo also shows the overhead telegraph wires which run across the floodplain throughout the lower Mossat.

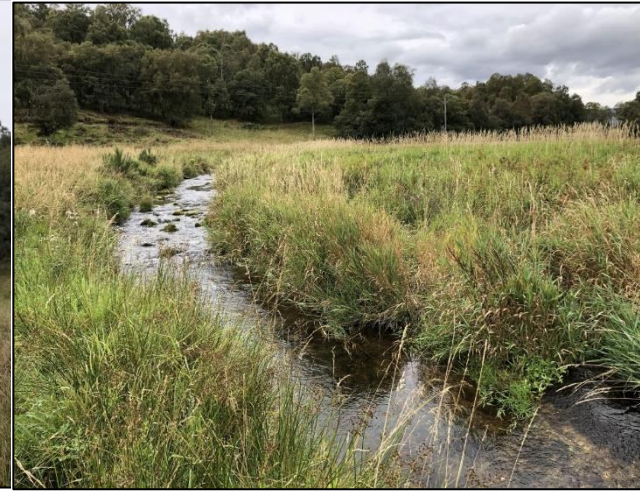
**Figure 3.30.** Rushes on the floodplain indicate good channel/floodplain connectivity and high-water table. Implementation of LWS here could promote increased out-of-channel flows.

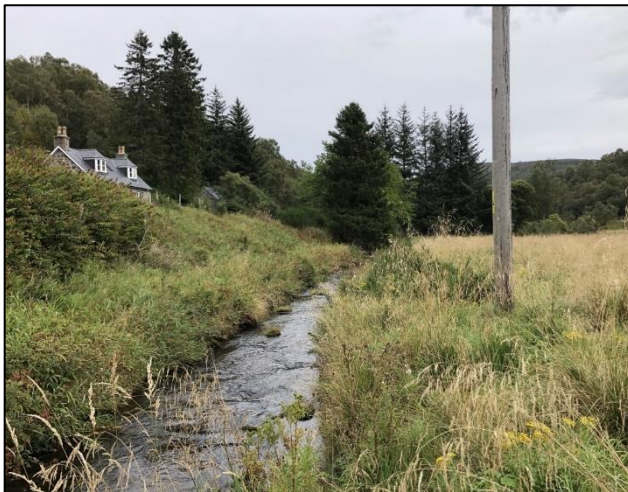
**Figure 3.31.** Typical plane bed morphology present throughout the site.

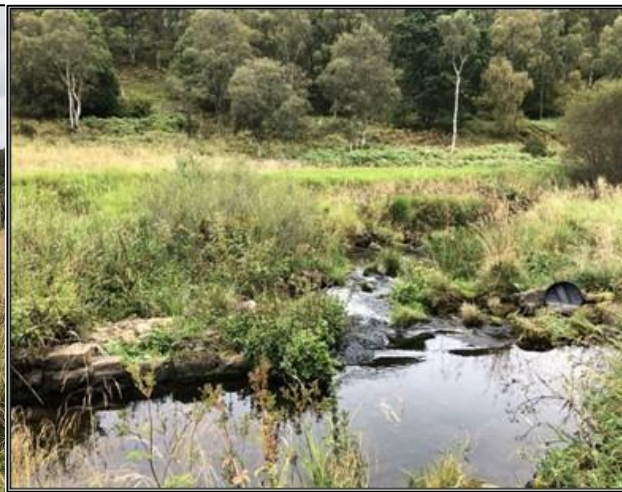
**Figure 3.32.** Partially intact boulder weir located at OS NGR NJ 48849 18692.

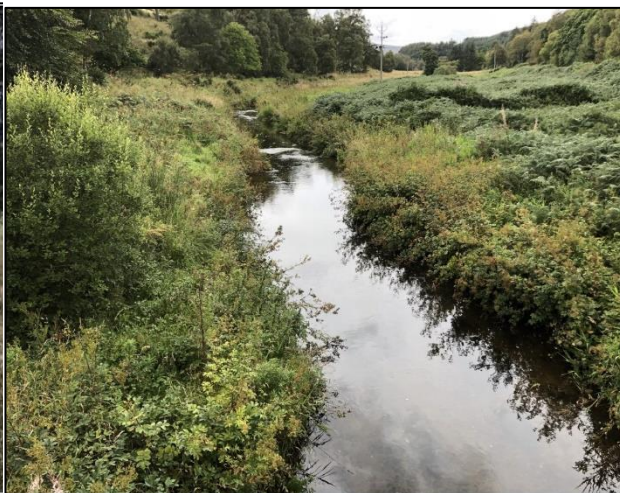
**Figure 3.35** The Mossat burn upstream of the Ardhuncart Estate access track bridge. Slow glide morphology indicates that the channel is constricting flow and creating a backwater effect.

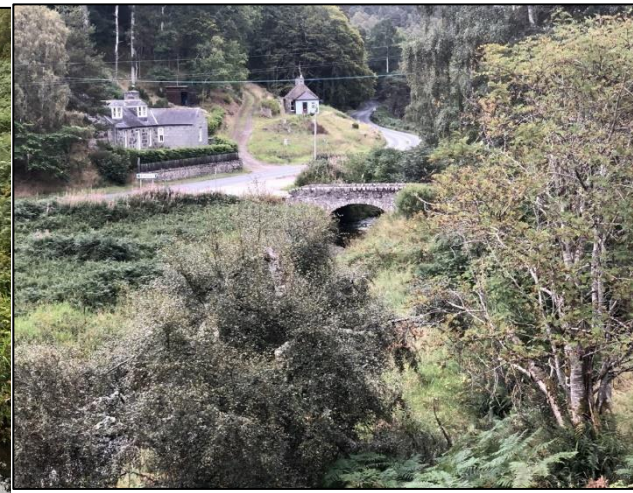
**Figure 3.36.** Arch bridge providing vehicular access to the Ardhuncart Estate. This bridge is positioned ~80 m upstream from the Mossat-Don confluence OS NGR NJ 49038 18555.

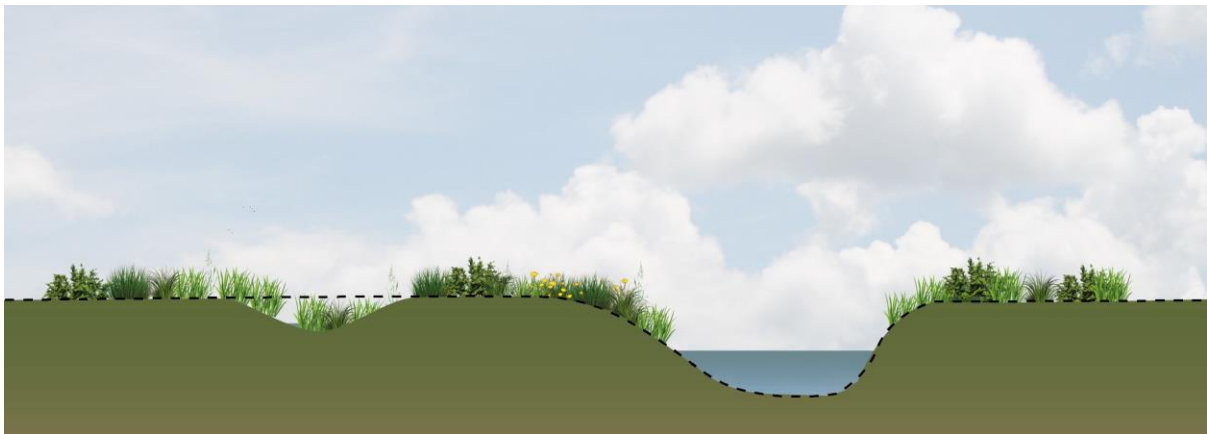
**Figure 4.3 Indicative cross section illustrating floodplain scrapes.**

Scrapes are shallow ponds that form naturally in areas of lower floodplain topography, often in association with relict meanders that have become partially infilled over time (Figure 4.3). These wetter areas provide important habitat for wildlife, especially in agricultural areas where the existing habitat has been simplified and degraded over time. In particular, these features provide important habitat for aquatic wildlife, wading birds, amphibians and small mammals and are often the only wet habitat in farmed landscapes, which can make them important as wildlife corridors. Scrapes can be designed specifically to meet habitat requirements of target species if required and can be fed by rivers, surface water, rainfall and/or groundwater and are often dry during the summer months but can store water in the winter months. Scrapes can contribute to flood management, although the flood risk benefit from constructing/enhancing scrapes in a single area is likely to be modest.

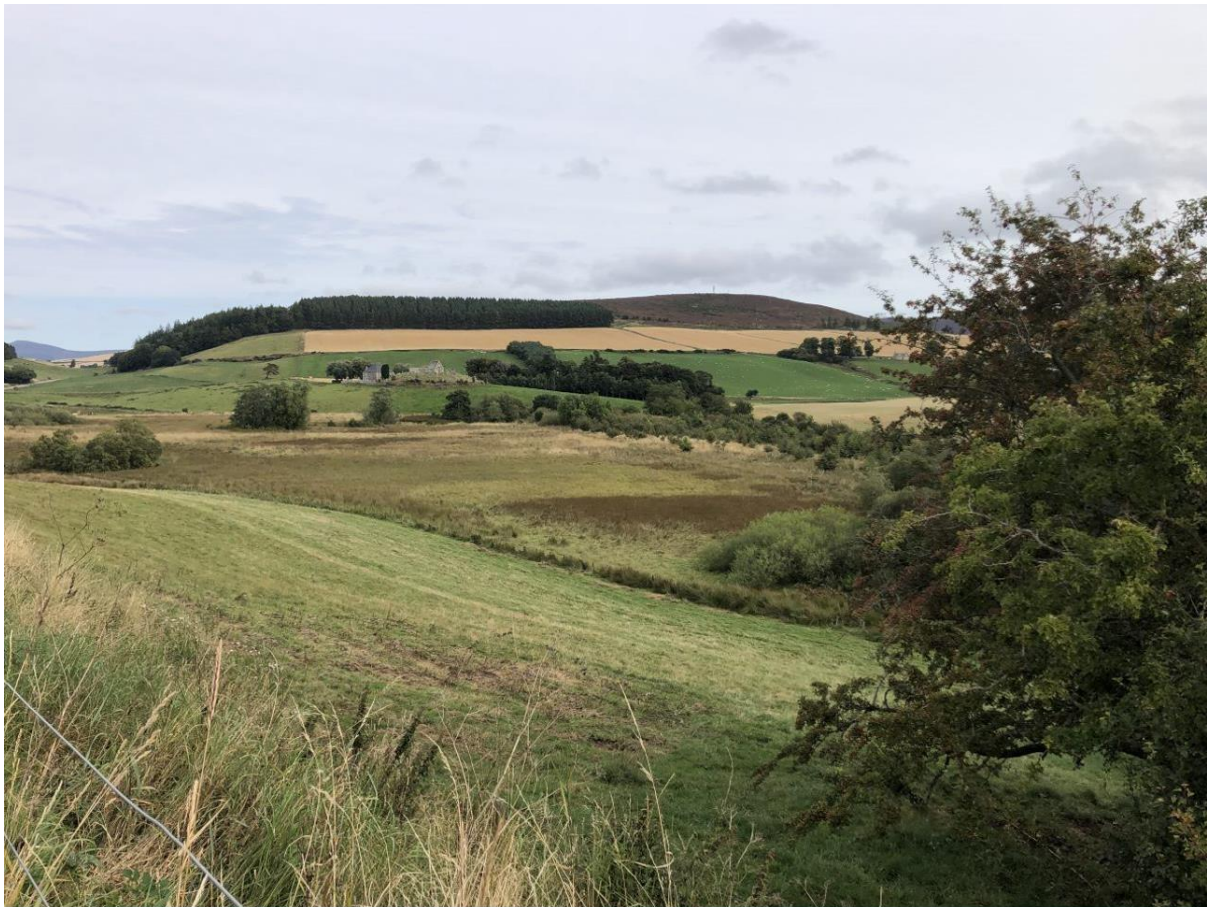
**Figure 4.4 Looking towards the north-east across Templeton Bog towards St. Bride's Chapel. Floodplain scrapes could be excavated to enhance flood storage within Templeton Bog.**

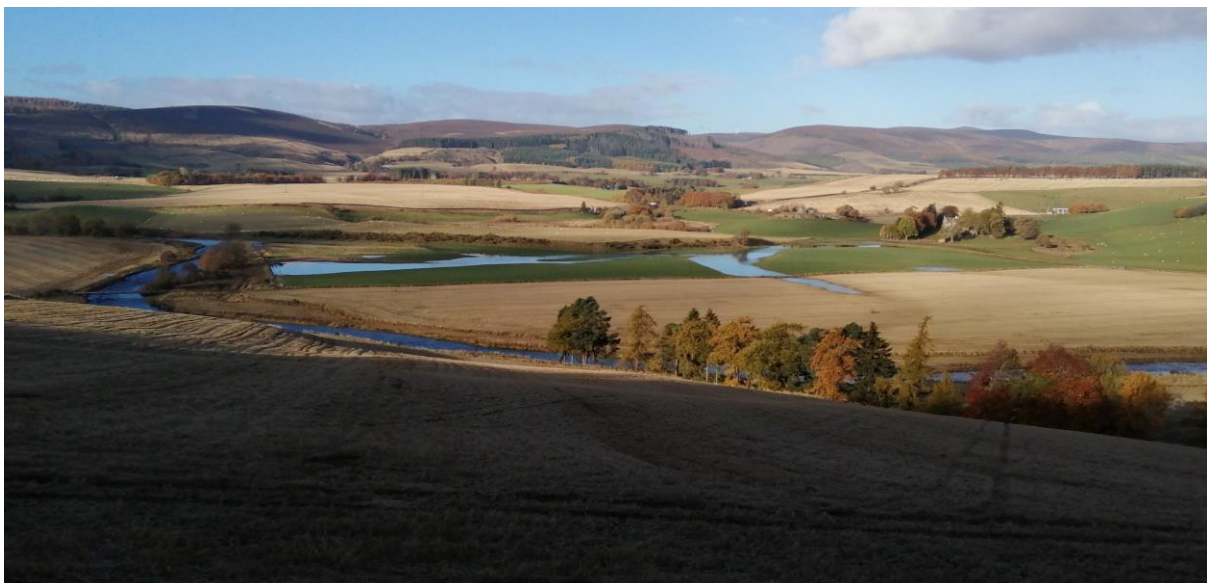
**Figure 4.5 Looking towards the west across the River Don towards the floodplain between the embankment breach area and the Auld Water. Areas of the floodplain could be excavated to create wetland scrapes and ponds to enhance existing areas of surface water residence.**

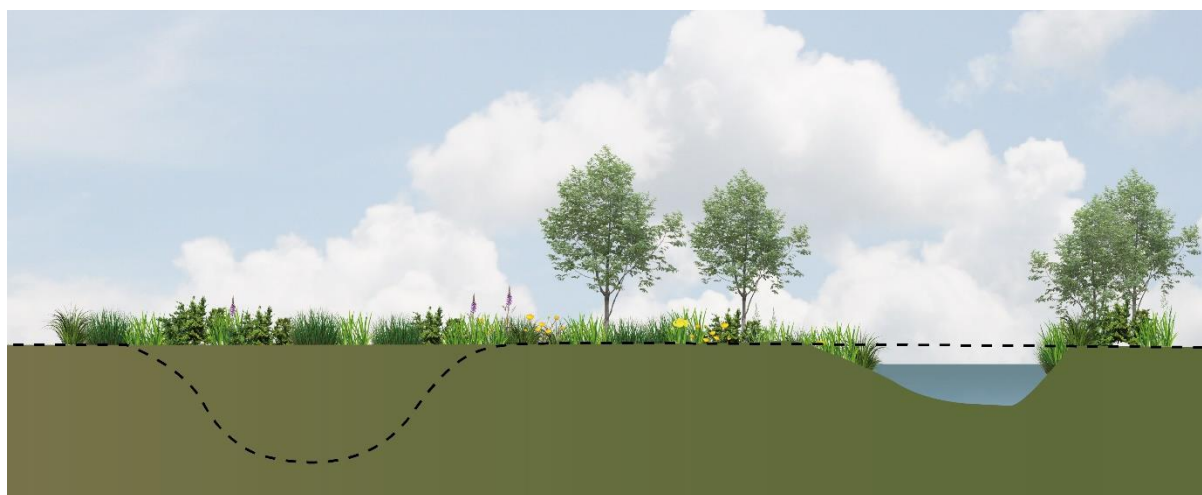
**Figure 4.6 Indicative cross section illustrating channel realignment.**

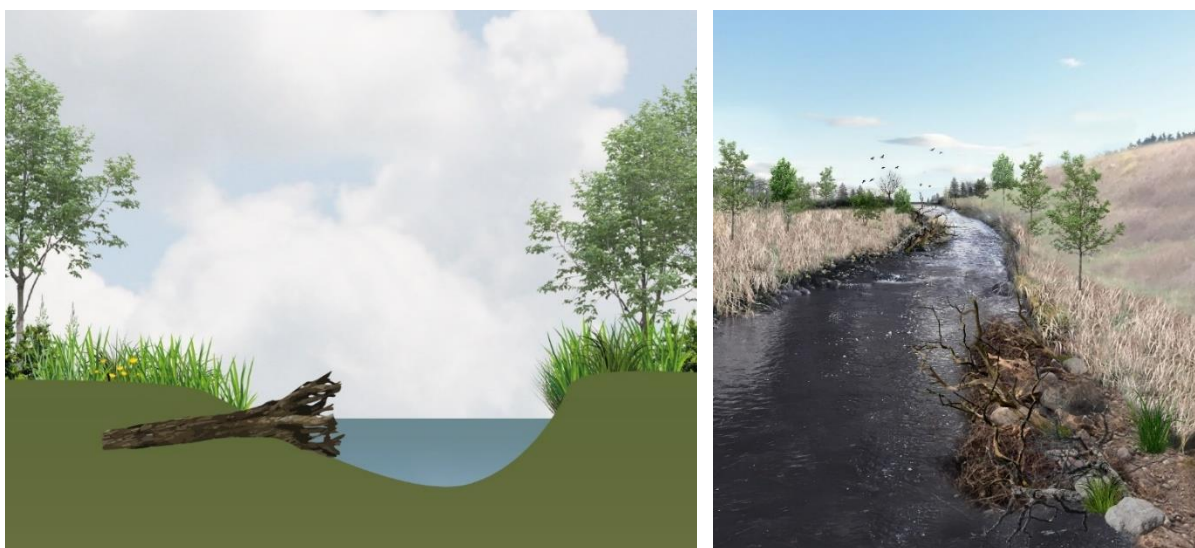
**Figure 4.8 Illustrative example of large wood placement. Left: cross-sectional view of a channel, Right: structures installed on alternate banks.**

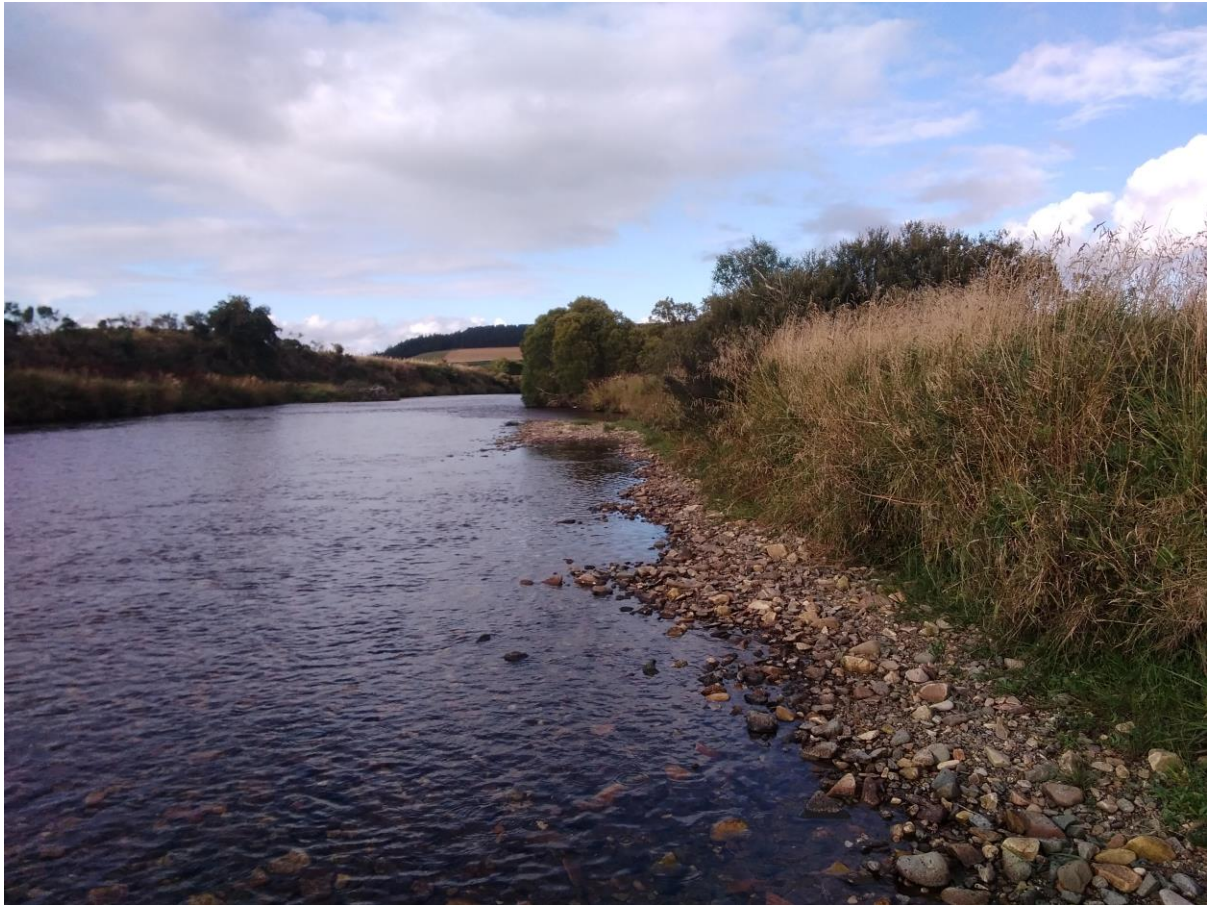
**Figure 4.9 Example of a proto bar on the river right bank of the Don that could be enhanced through LWS installation at the upstream extent of this feature.**

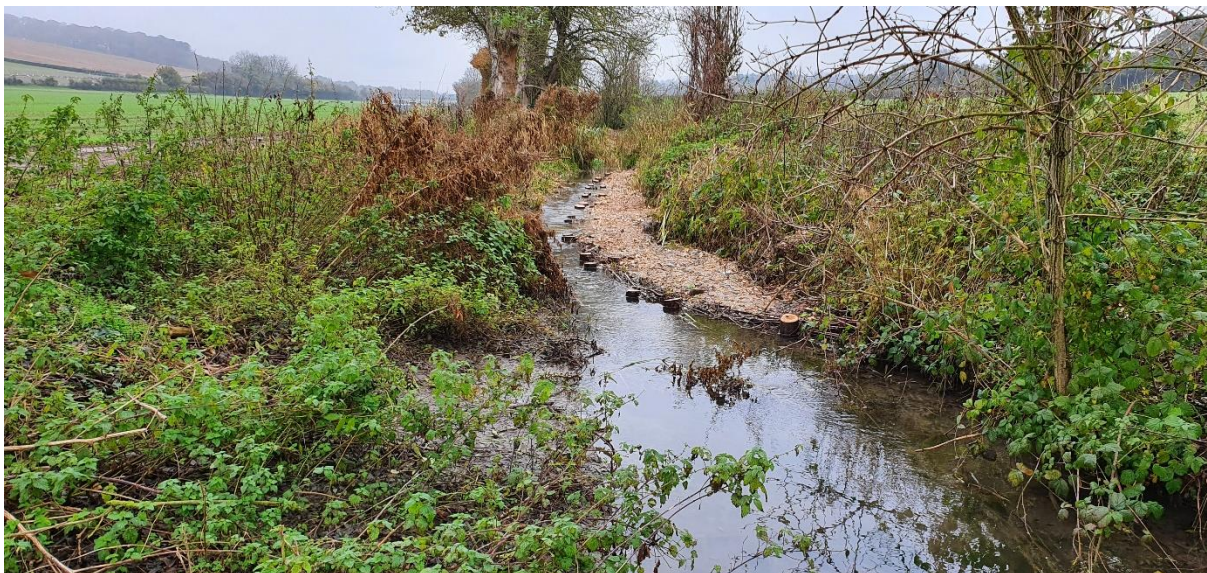
**Figure 4.11 Example of an in-channel bench constructed on the right bank of this river. The top of the brushwood with chestnut stakes, forming the outer edge of the bench can just be seen above the water surface.**

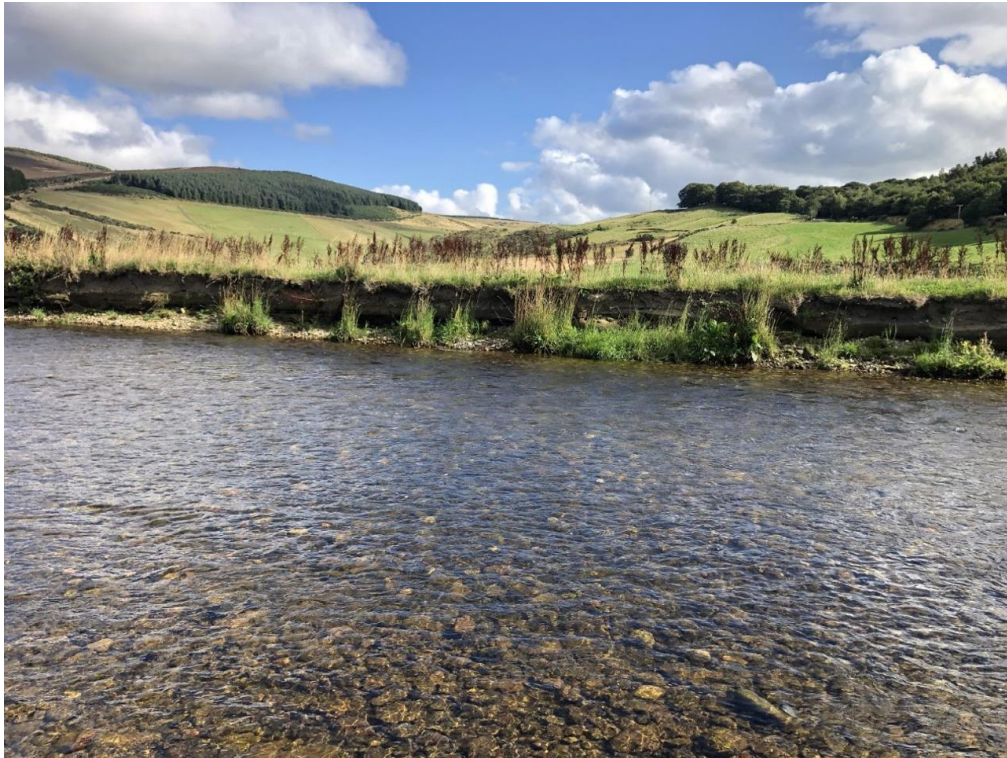
**Figure 4.14 Example of bank erosion on the river left bank, upstream of Cleek-Him-In-Pot pool. Bank height is between 1 to 1.5 m at this location.**

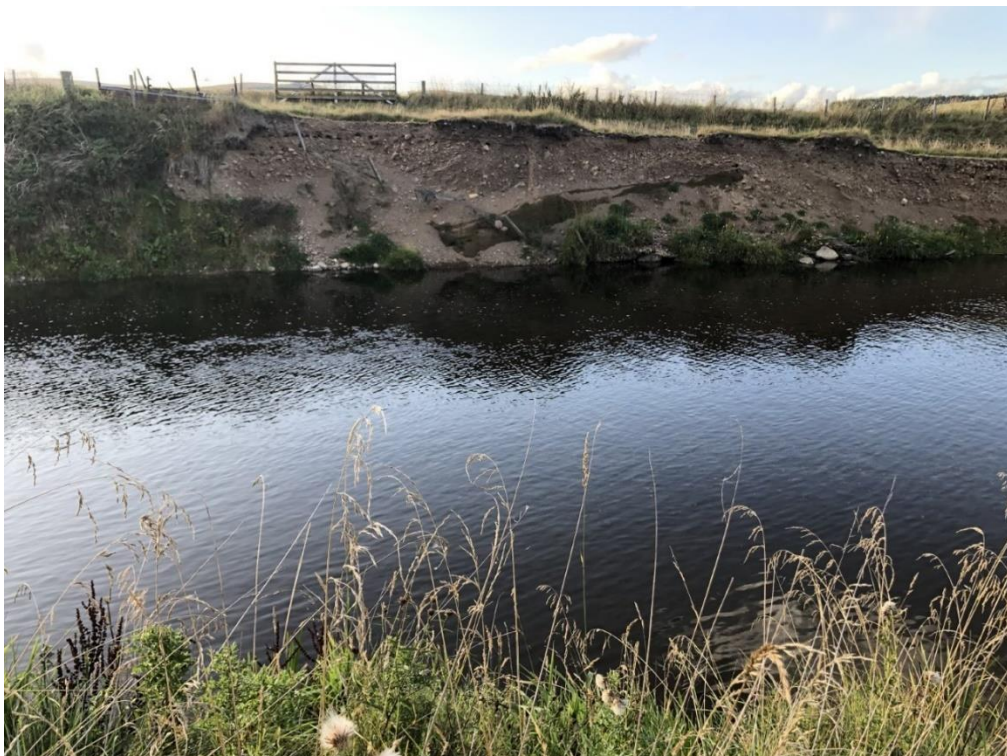
**Figure 4.15 Bank erosion between Jock Reid pool and the breached embankment. The track was previously positioned between the gate/fence line and the top of the channel bank, however this route is no longer safe to access due to the erosion and embankment breach. Bank height within this section ranges from 1 to 3 m.**

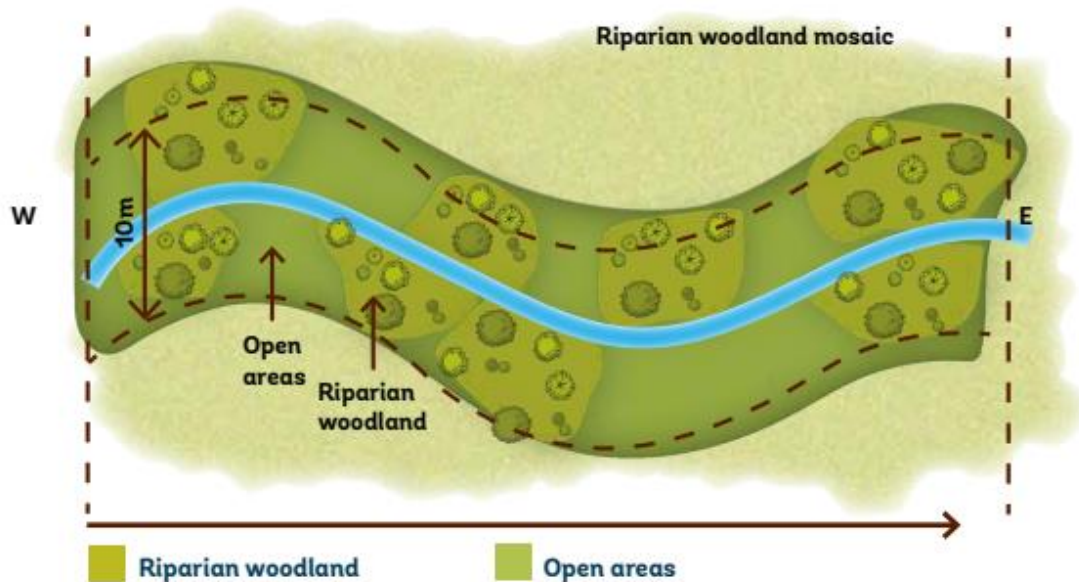
**Figure 4.17 Riparian woodland mosaic recommended to provide dappled shade to the watercourse and a variety of habitats within the riparian corridor. Source: Woodland Trust (2016).<sup>20</sup>**

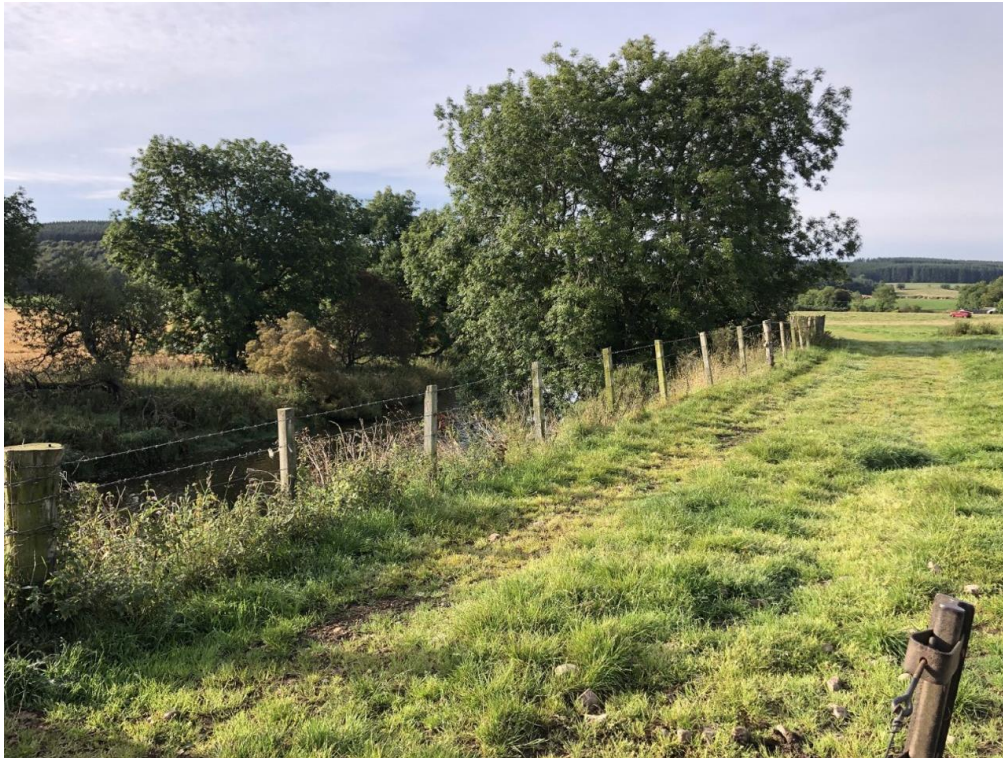
**Figure 4.19 Fence line positioned along the top of the River Don right bank, next to Jock Reid pool. This section of bank is just upstream of the bank erosion and embankment breach. Recommend to set-back the fence line and reprofile the bank, to provide long-term bank stability.**

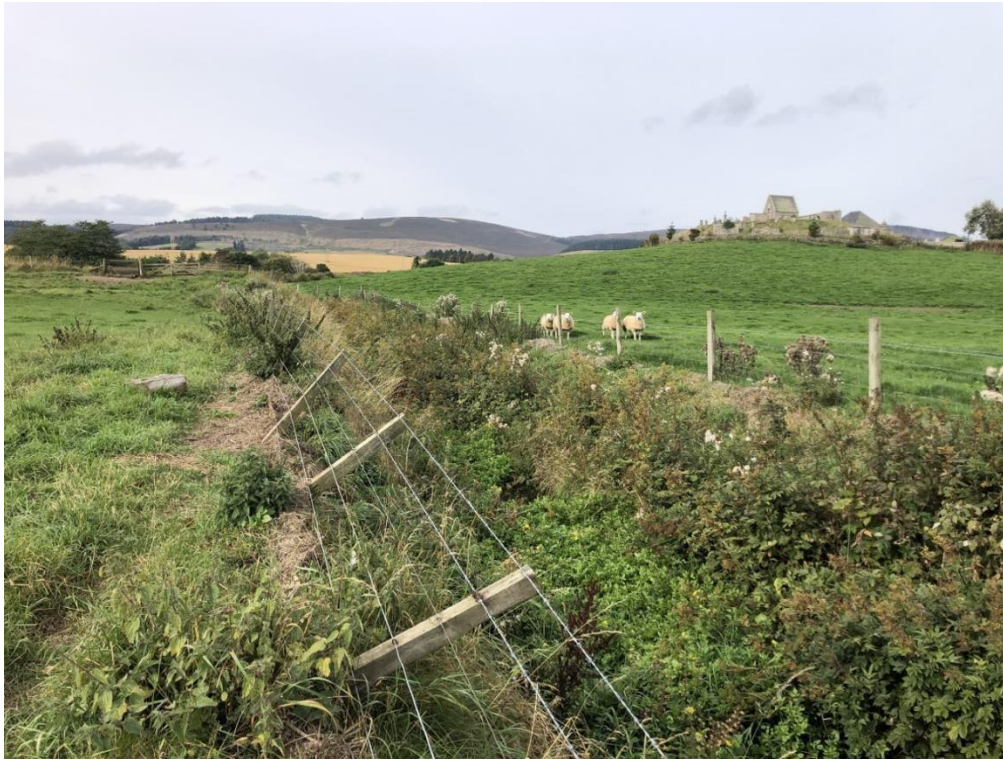
**Figure 4.20 Fence line undermined by bank erosion on the river right bank of the Auld Water. This section of erosion is noted within the same field as the embankment breach.**

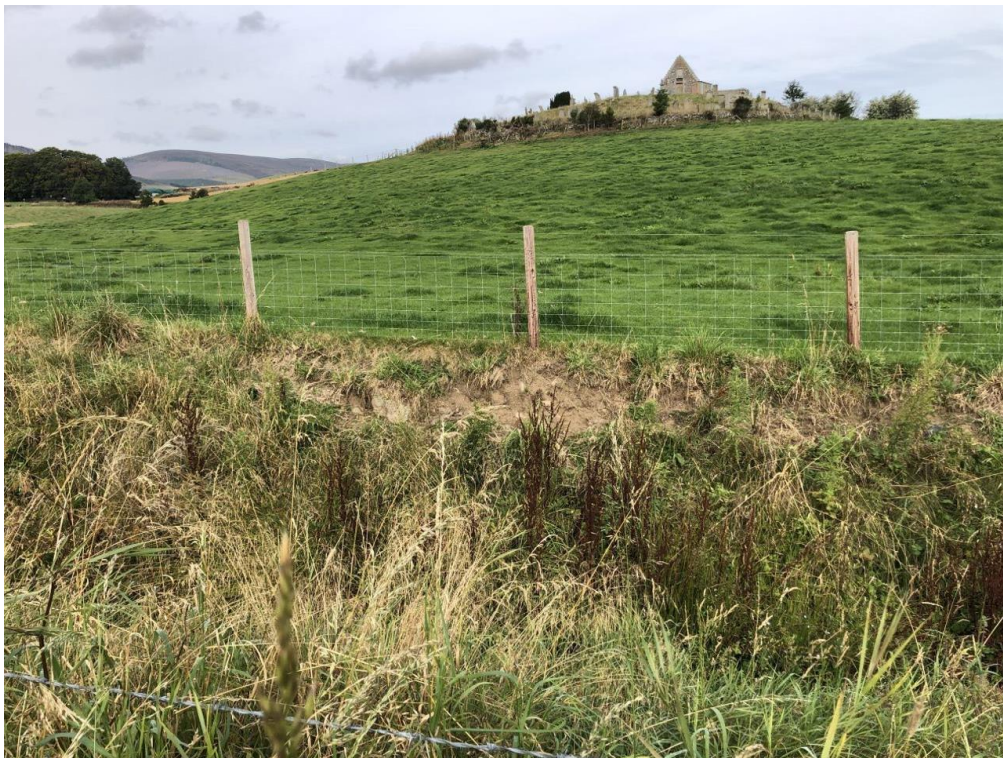
**Figure 4.21 Bank erosion observed on the river left bank within the same field as St. Brides Chapel. The fence line along the top of bank here is likely to be undermined in future flood events when this bank is subject to further erosion.**

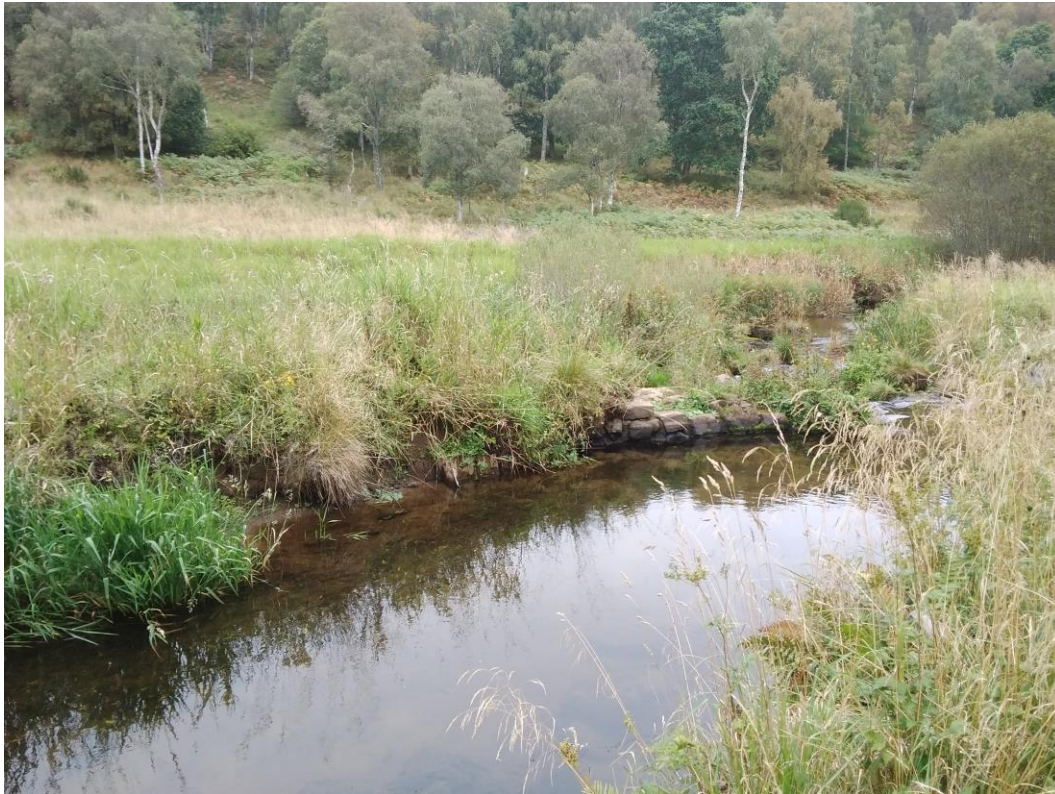
**Figure 4.22 Looking downstream towards the boulder weir on the Mossat Burn.**

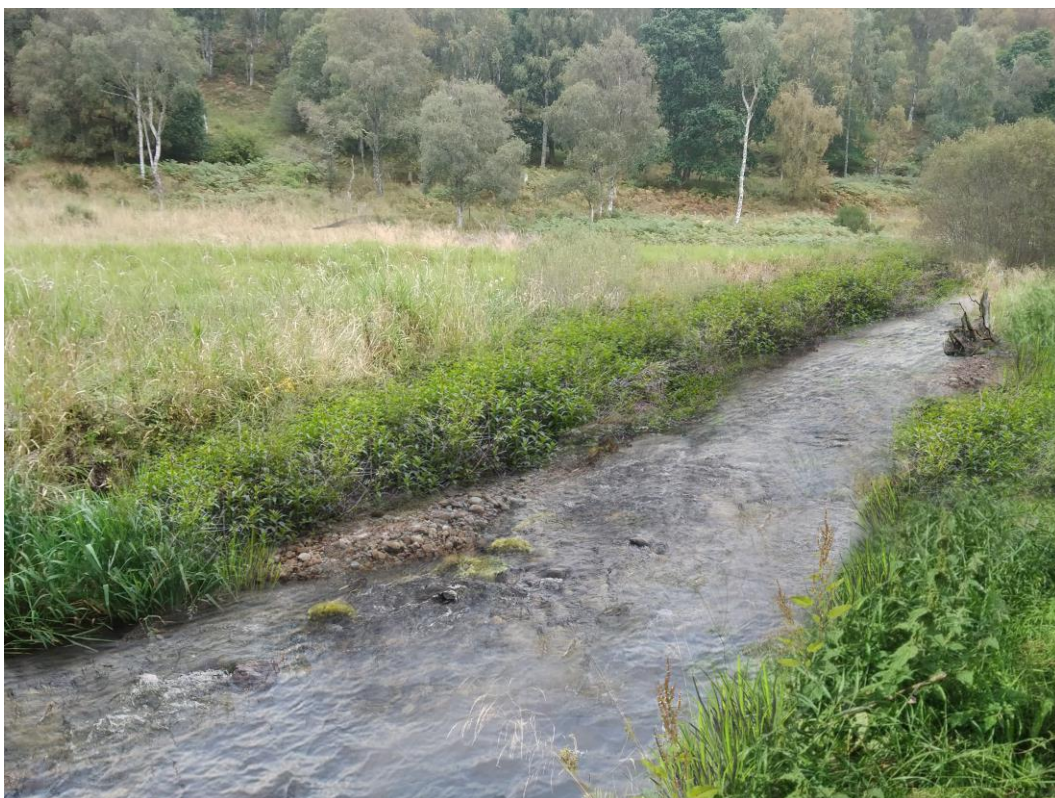
**Figure 4.23 Visualisation showing how the Mossat burn may look following weir removal and installation of LWS.**
