# River Don Scoping Study

Draft Report

Ardhuncart Estate

cbec eco-engineering UK Ltd

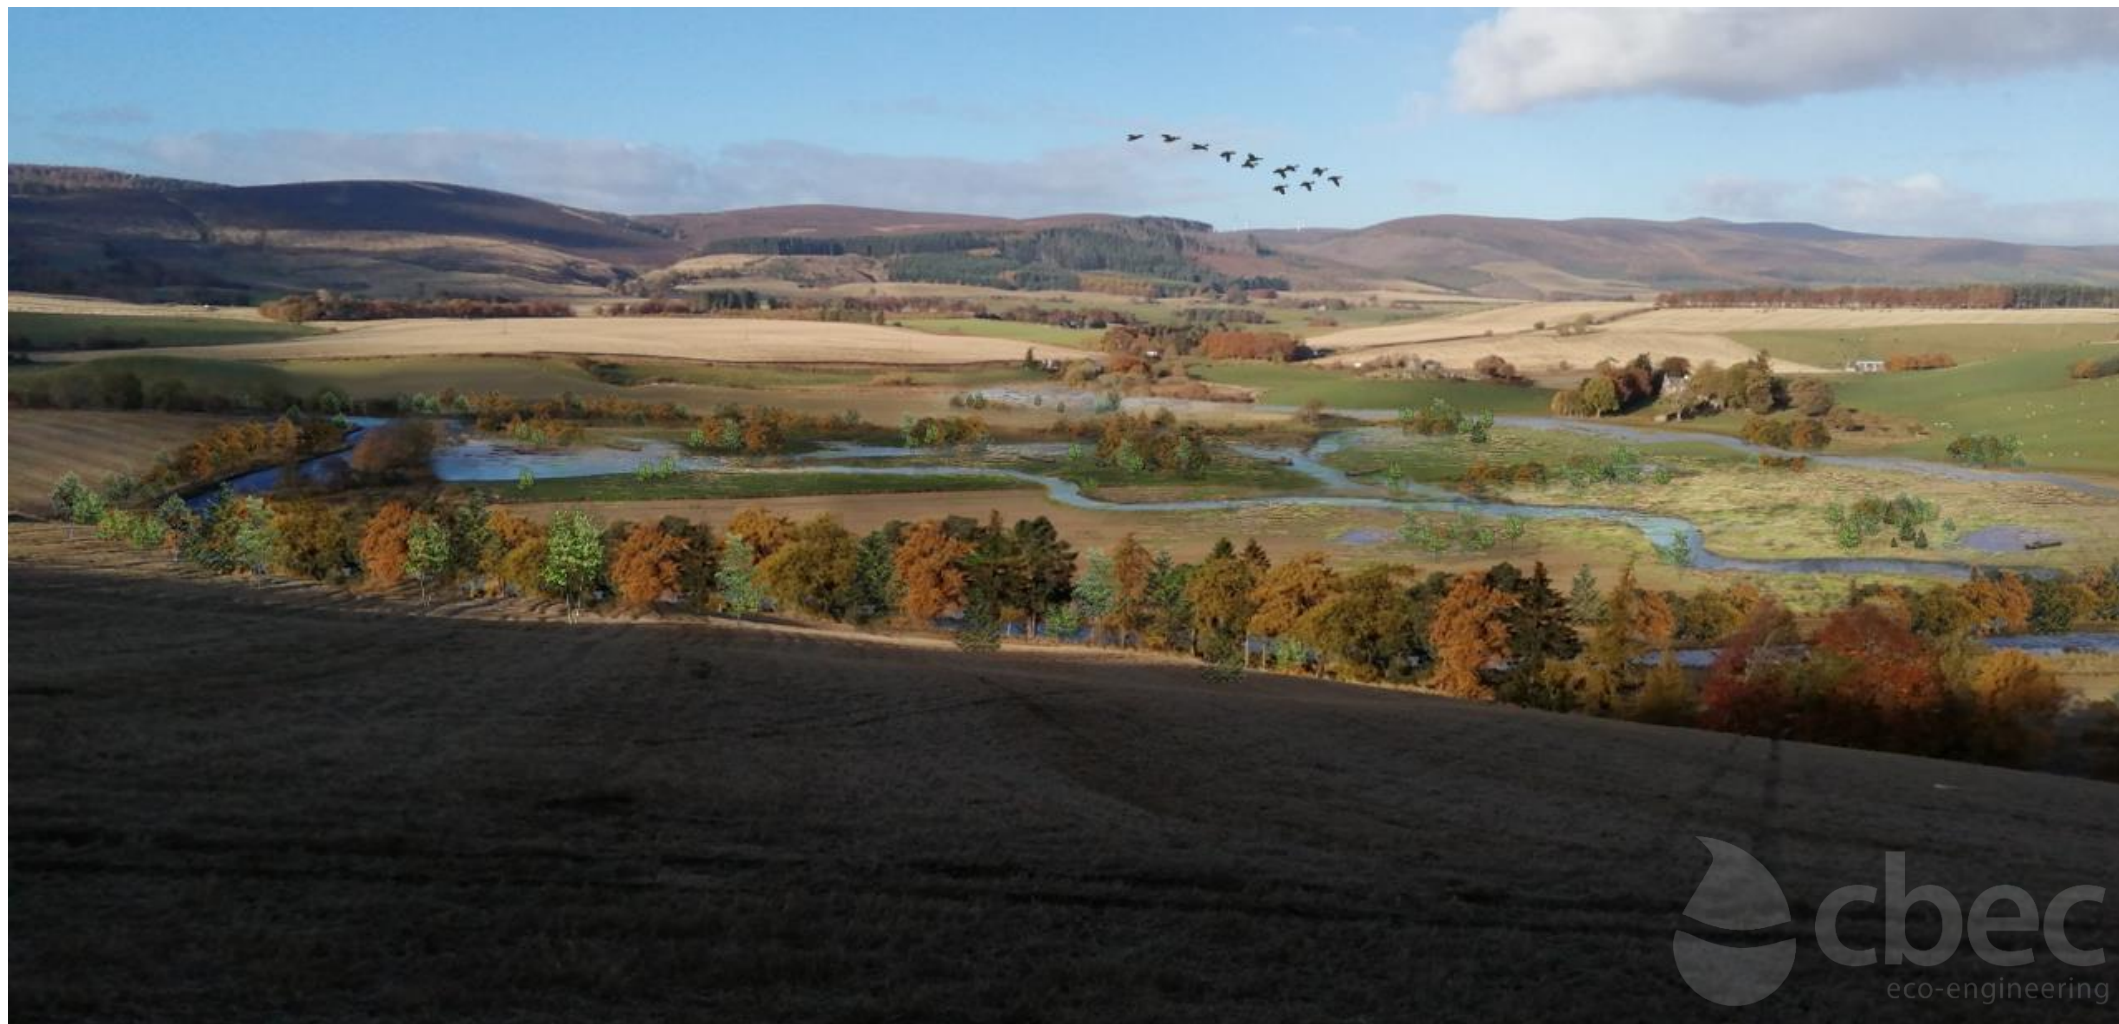
**Figure 4.27 Floodplain between the embankment breach and the Auld Water confluence (Option Area 3). Visualisation showing how this area may look with side channel creation, LWS and scrapes on the floodplain as well as riparian corridor improvements.**
